CERTIFICATE OF APPROPRIATENESS

Property: 202 E 10th Street, Tracts 23A and 24A, Block 229, Houston Heights Subdivision. The property includes a historic 2,695 square foot two-story wood frame single-family residence and a detached garage situated on an 8,200 square foot (82' x 100') corner lot.

Proposal: Alteration – Windows/Siding

- Remove vinyl siding, asphalt shingle siding that is underneath the vinyl, and wood 105 siding that is under the shingle siding, and install new smooth-finish cementitious siding with a 5" reveal;
- Remove 39 original wood, 1-over-1 windows and one non-original, aluminum window, and install new wood windows in the same openings.

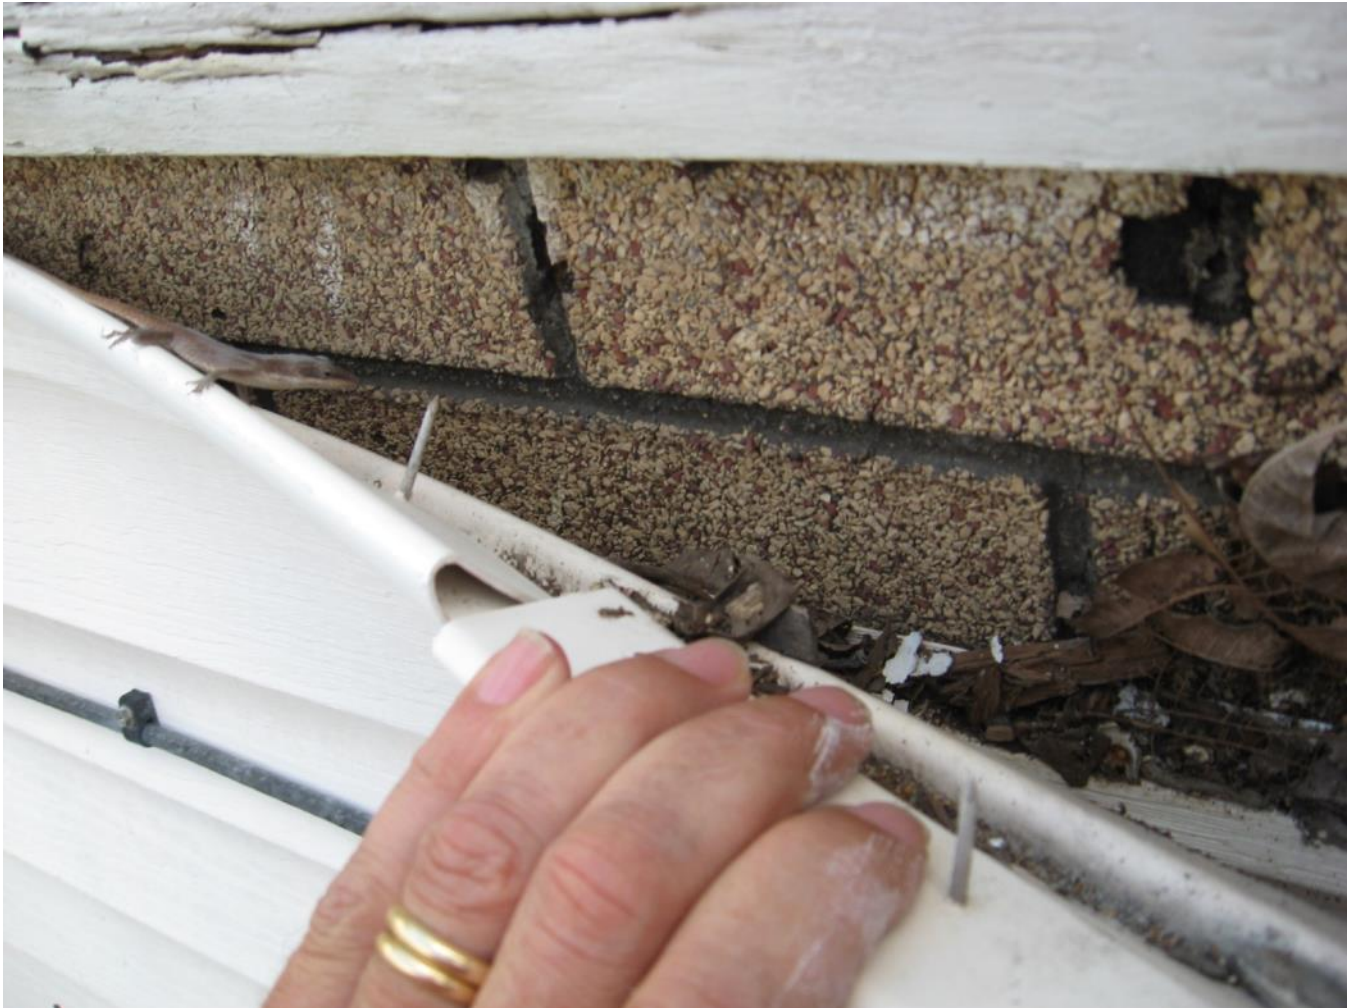
VINYL SIDING COVERING SHINGLE SIDING

A spot check confirmed the presence of siding underneath the vinyl and asphalt, until the other materials are fully removed to see if any damage is present, the wood siding should be retained and repaired.

Approval to remove vinyl and asphalt siding; Denial to remove wood siding and replace with cementitious siding.
